Effects of bank vegetation in waterways with special reference to bank erosion, shear strength, root density and channel hydraulics

**Effects of Bank Vegetation in Waterways with Special
Reference to Bank Erosion, Shear Strength, Root Density and
Channel Hydraulics**

**A thesis submitted to the Open University
for the Degree of Doctor of Philosophy
Biology Department
September 1992**

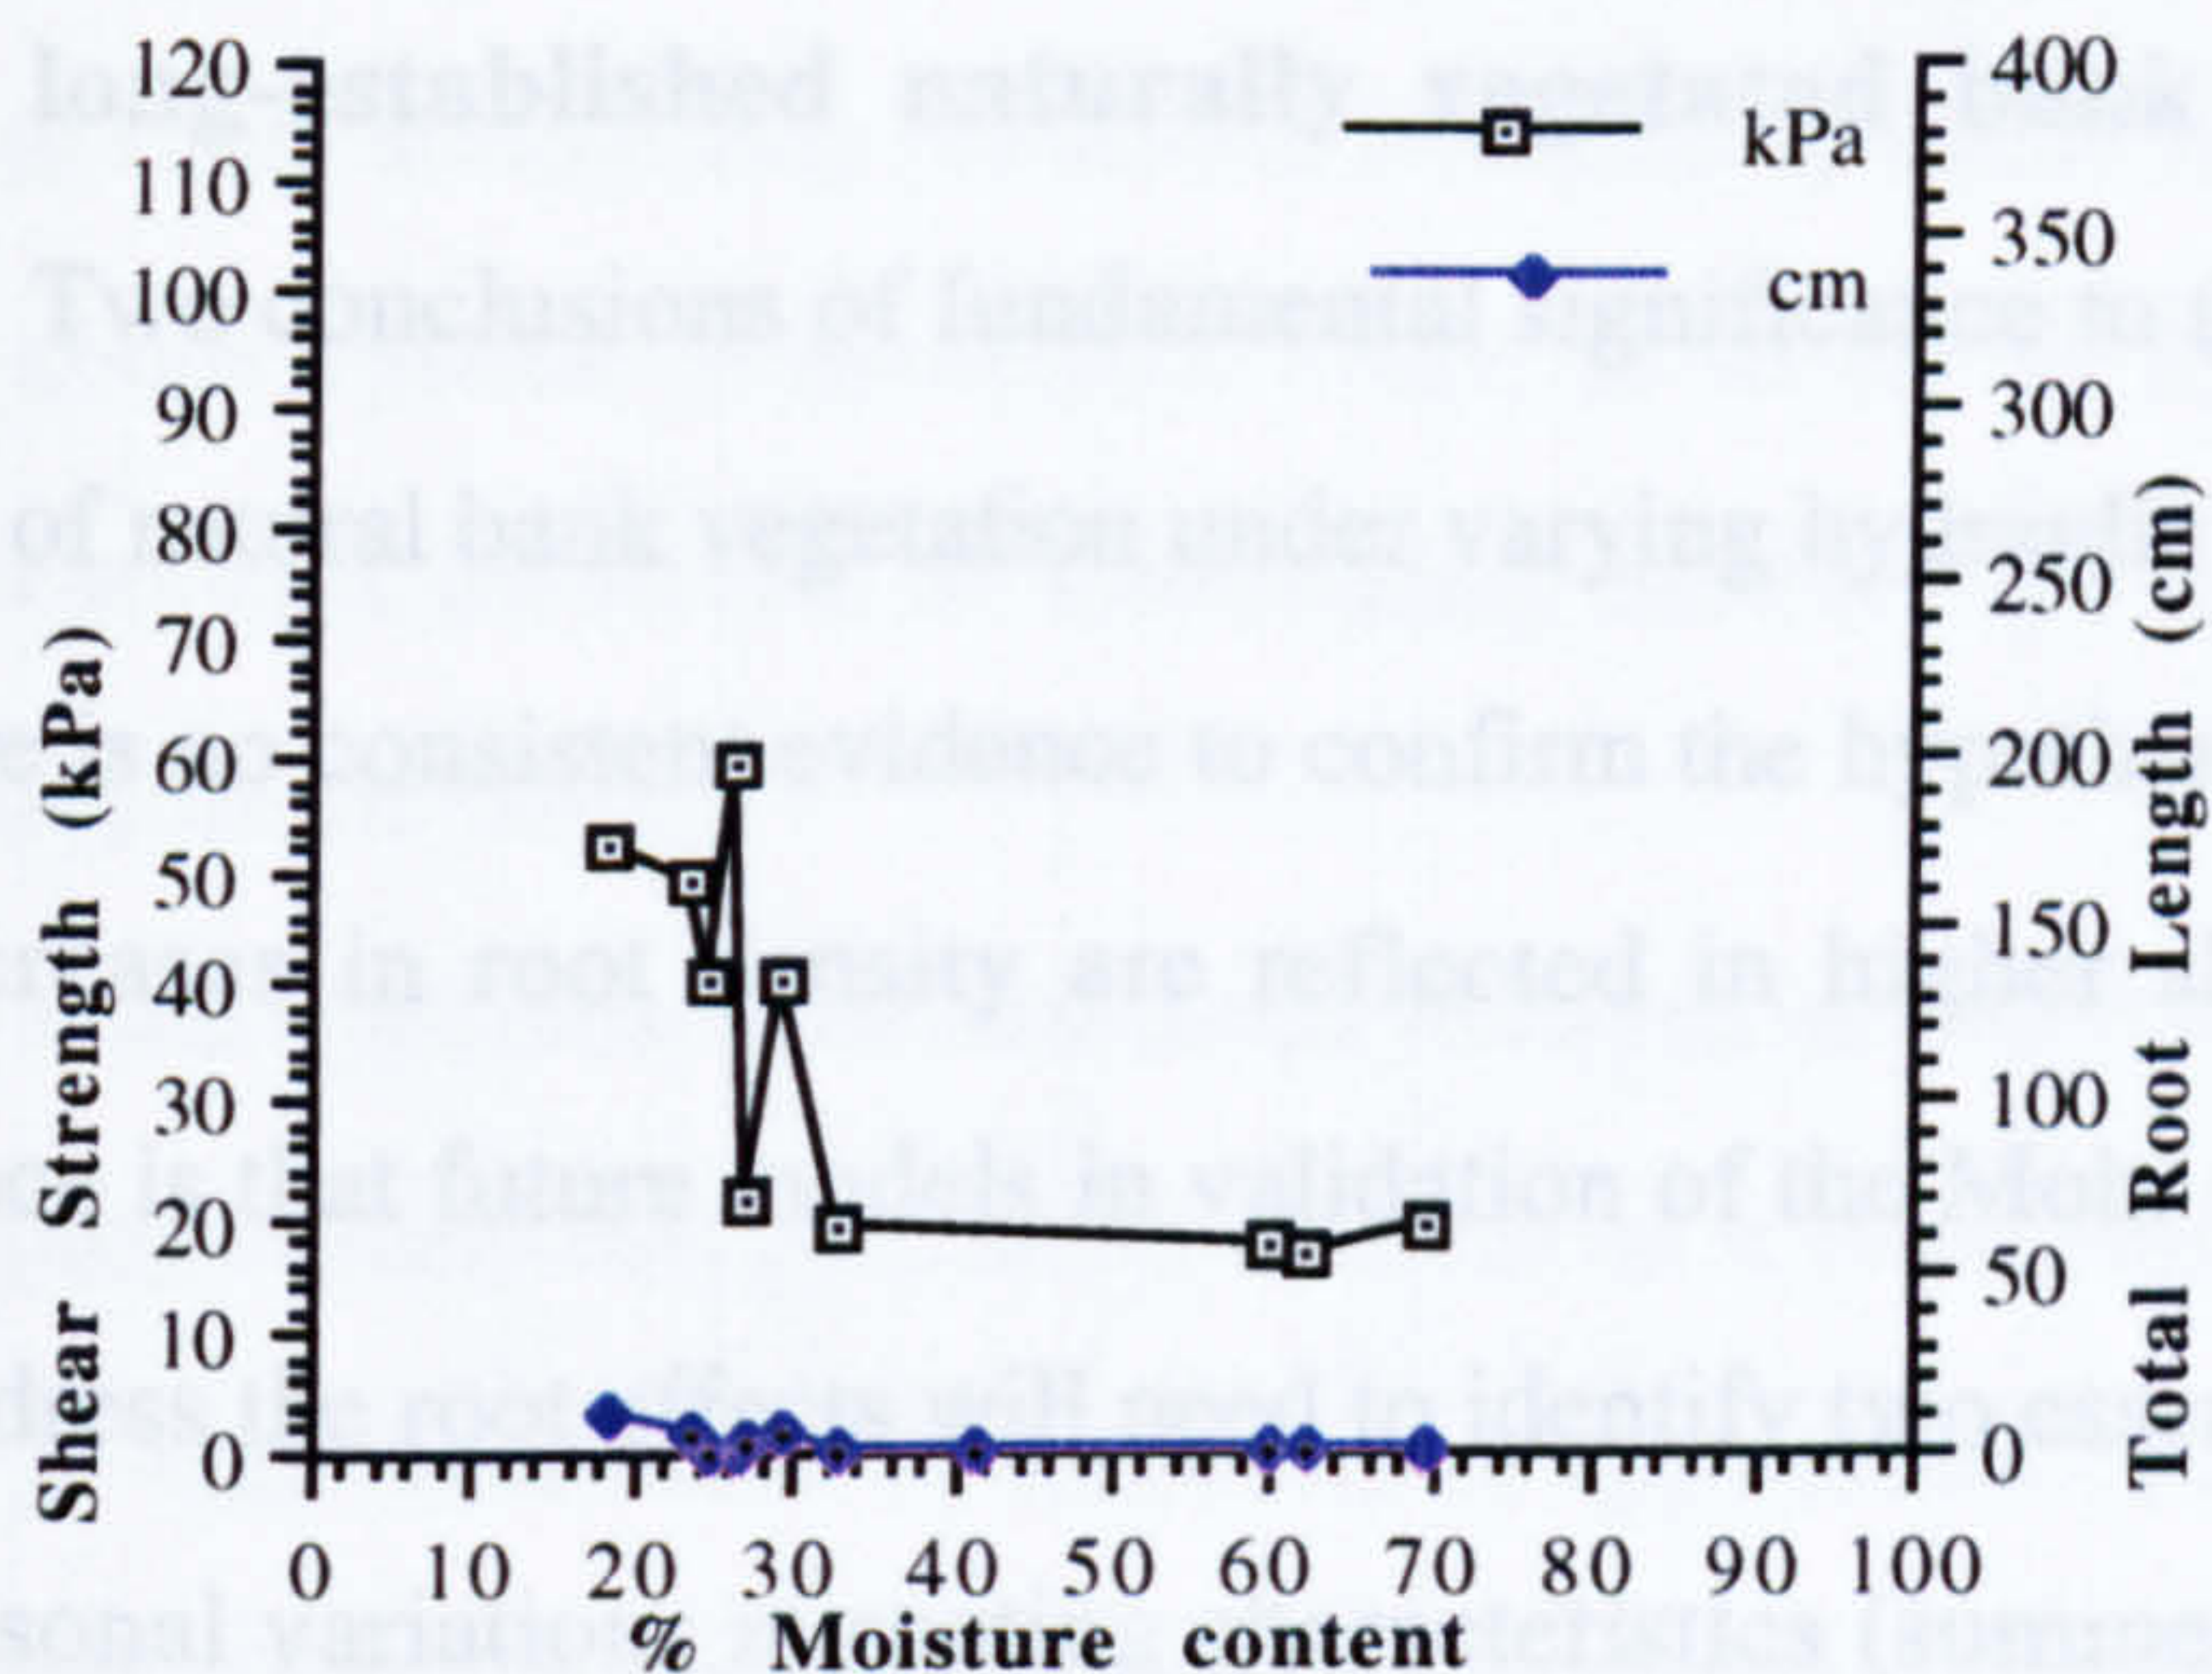
Fig. 3.15a : Shear strength, Root length and Moisture content variations (August 198) Bare banks;

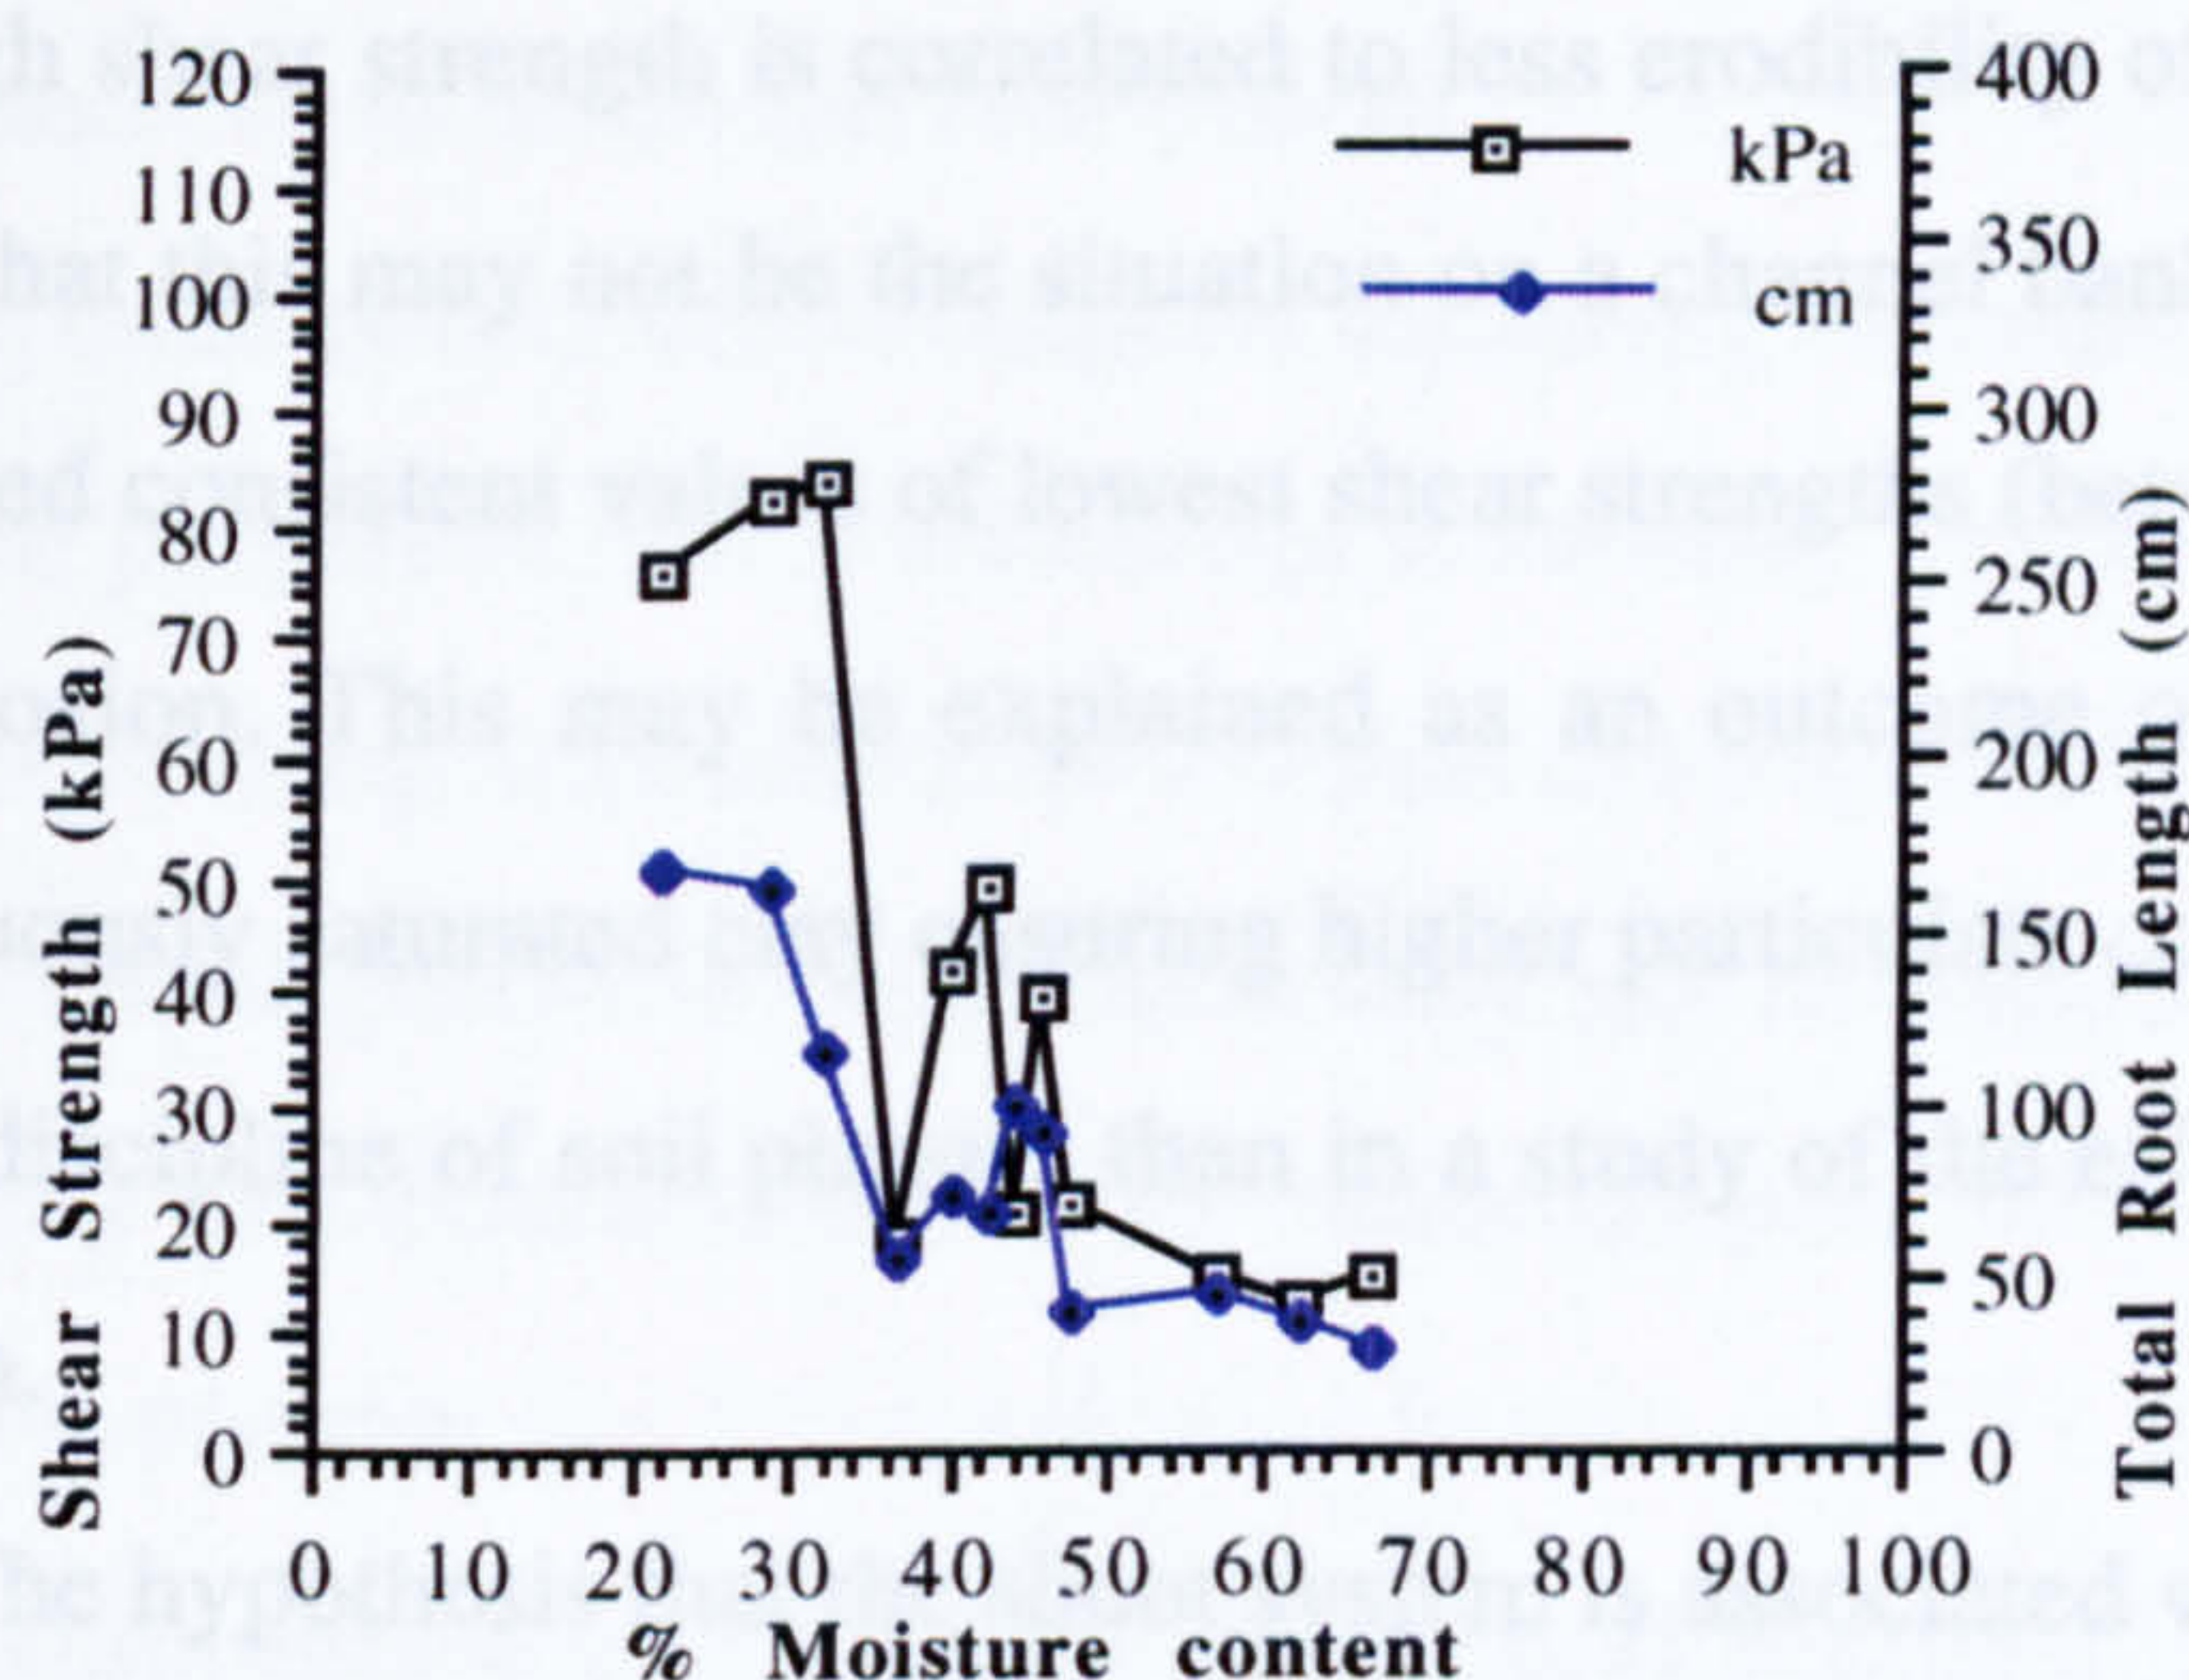
Fig. 3.15b : Shear strength, Root length and Moisture content variations (August 19) Naturally vegetated banks dominated by *E. hirsutum* at levels 2 to 4;

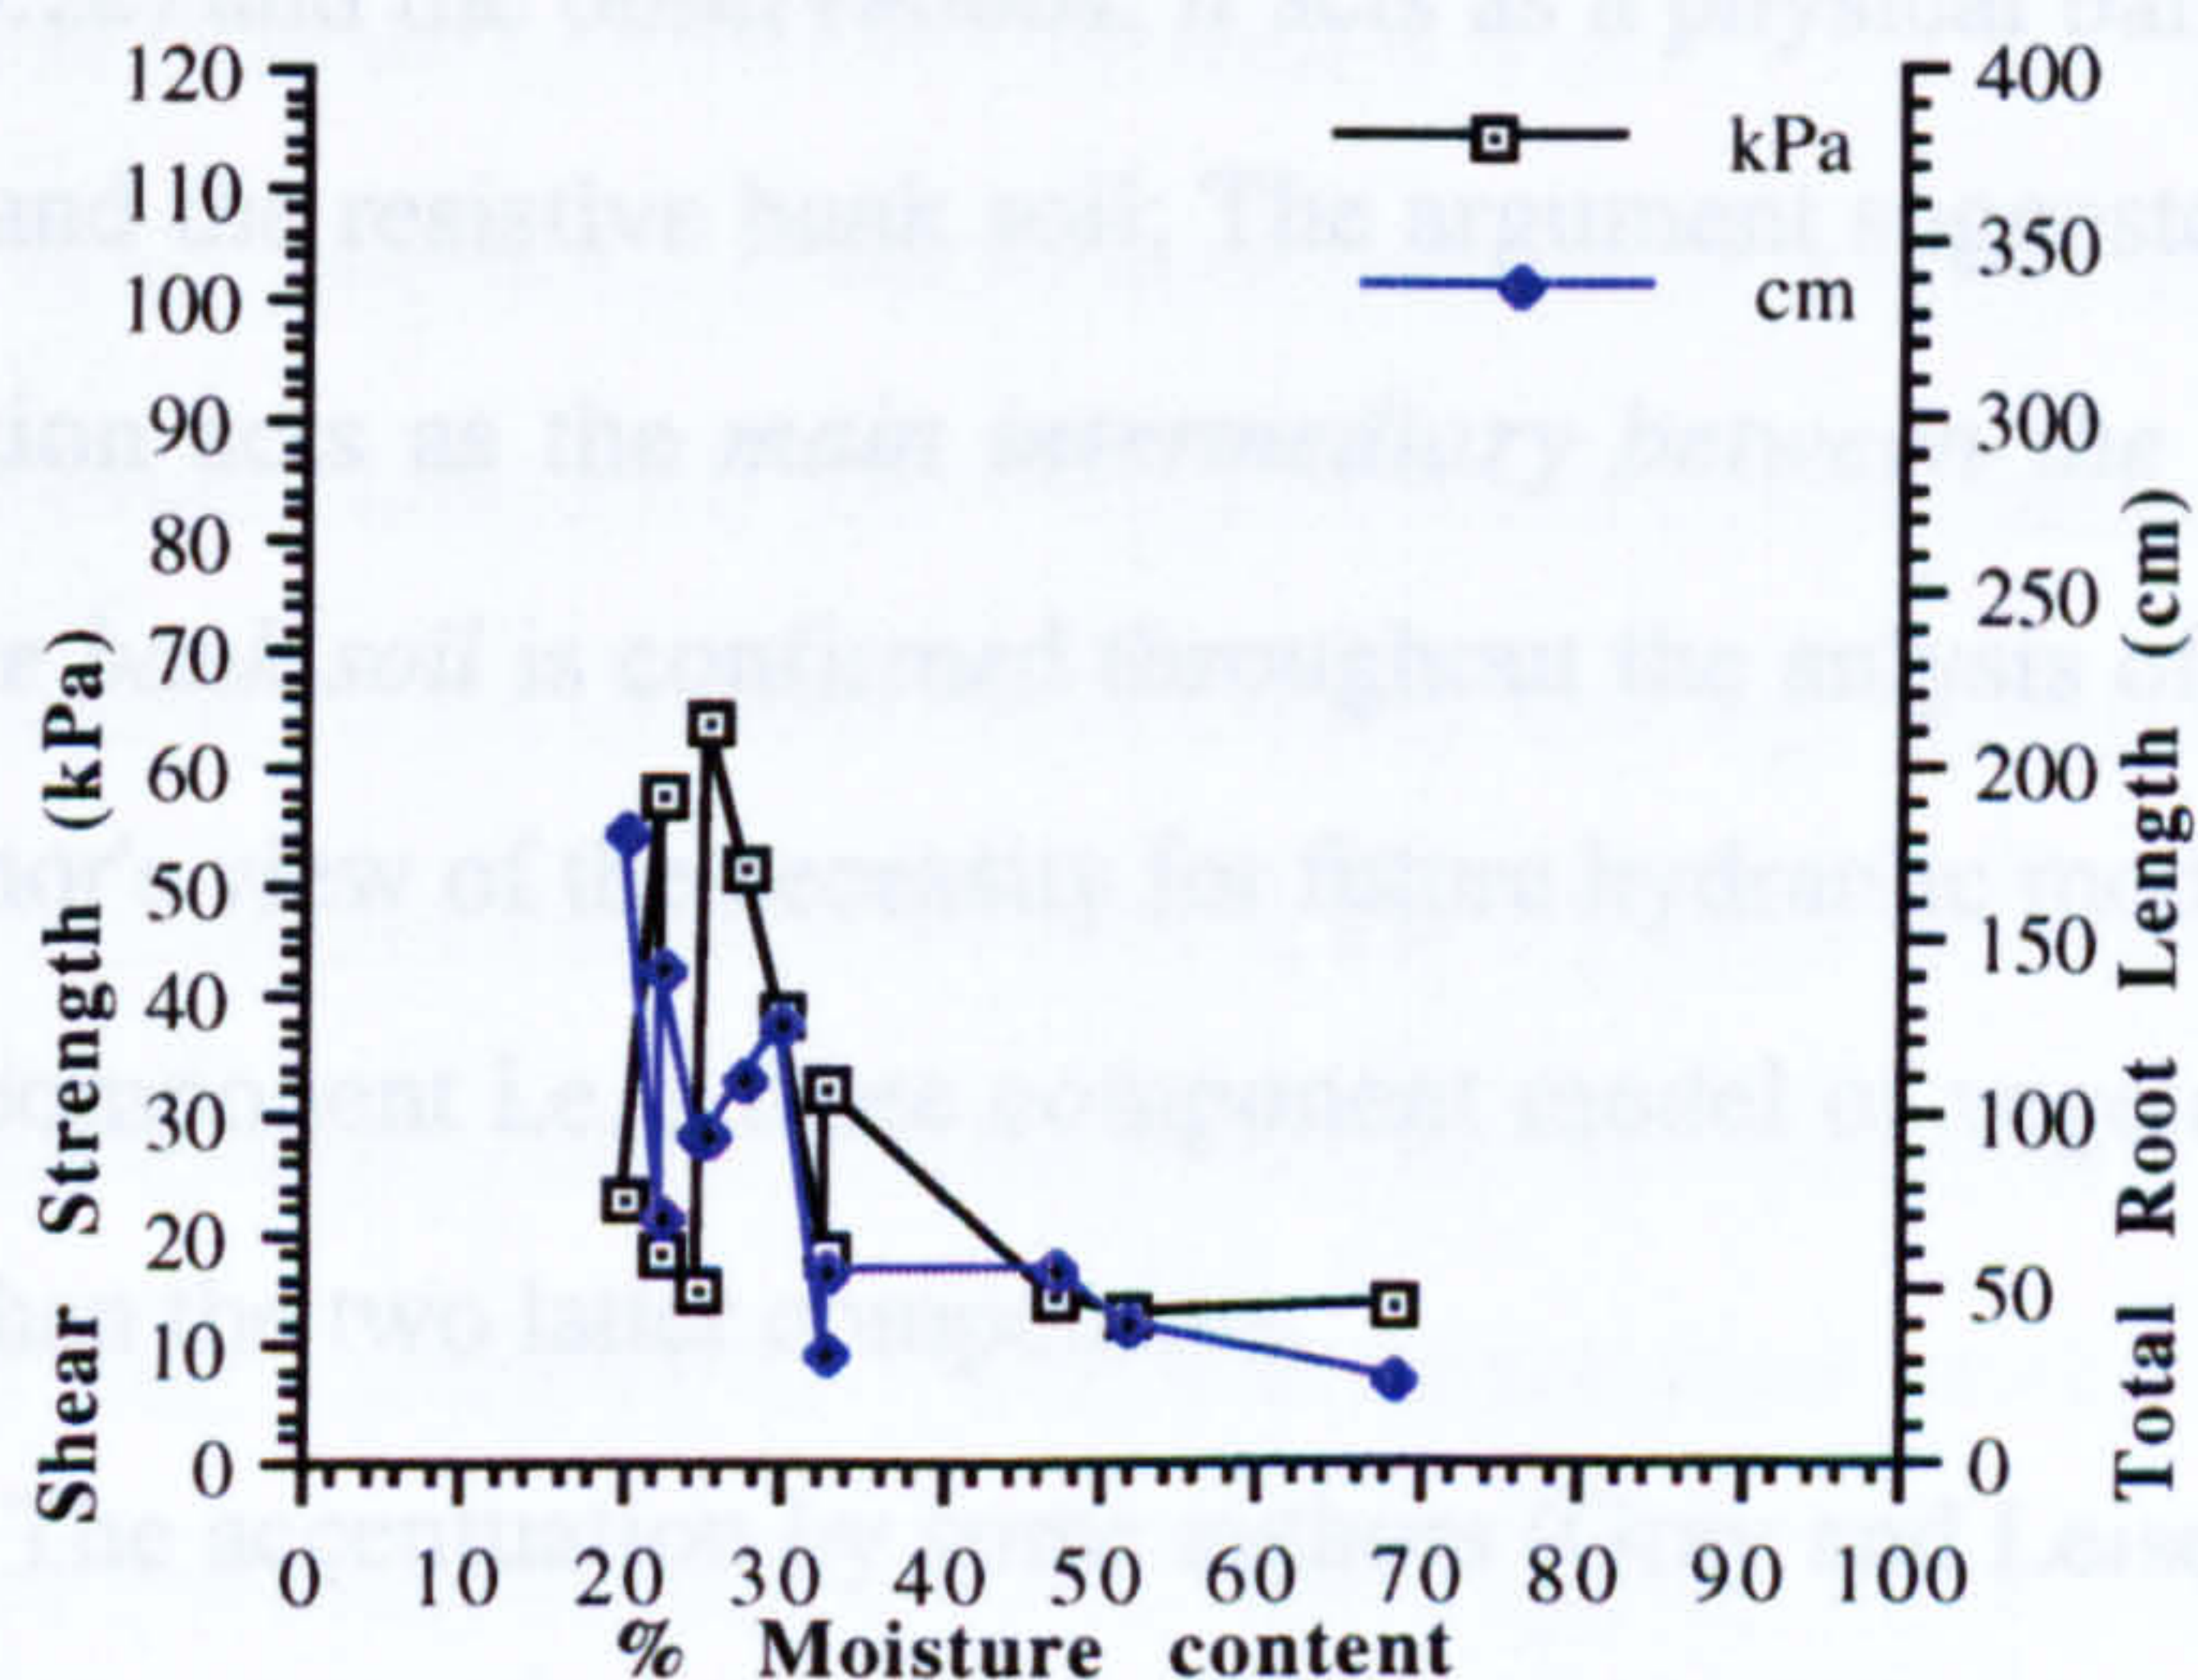
Fig. 3.15c : Shear strength, Root length and Moisture content variations (August 198) Naturally vegetated banks dominated by *U. dioica* at levels 2 to 4;

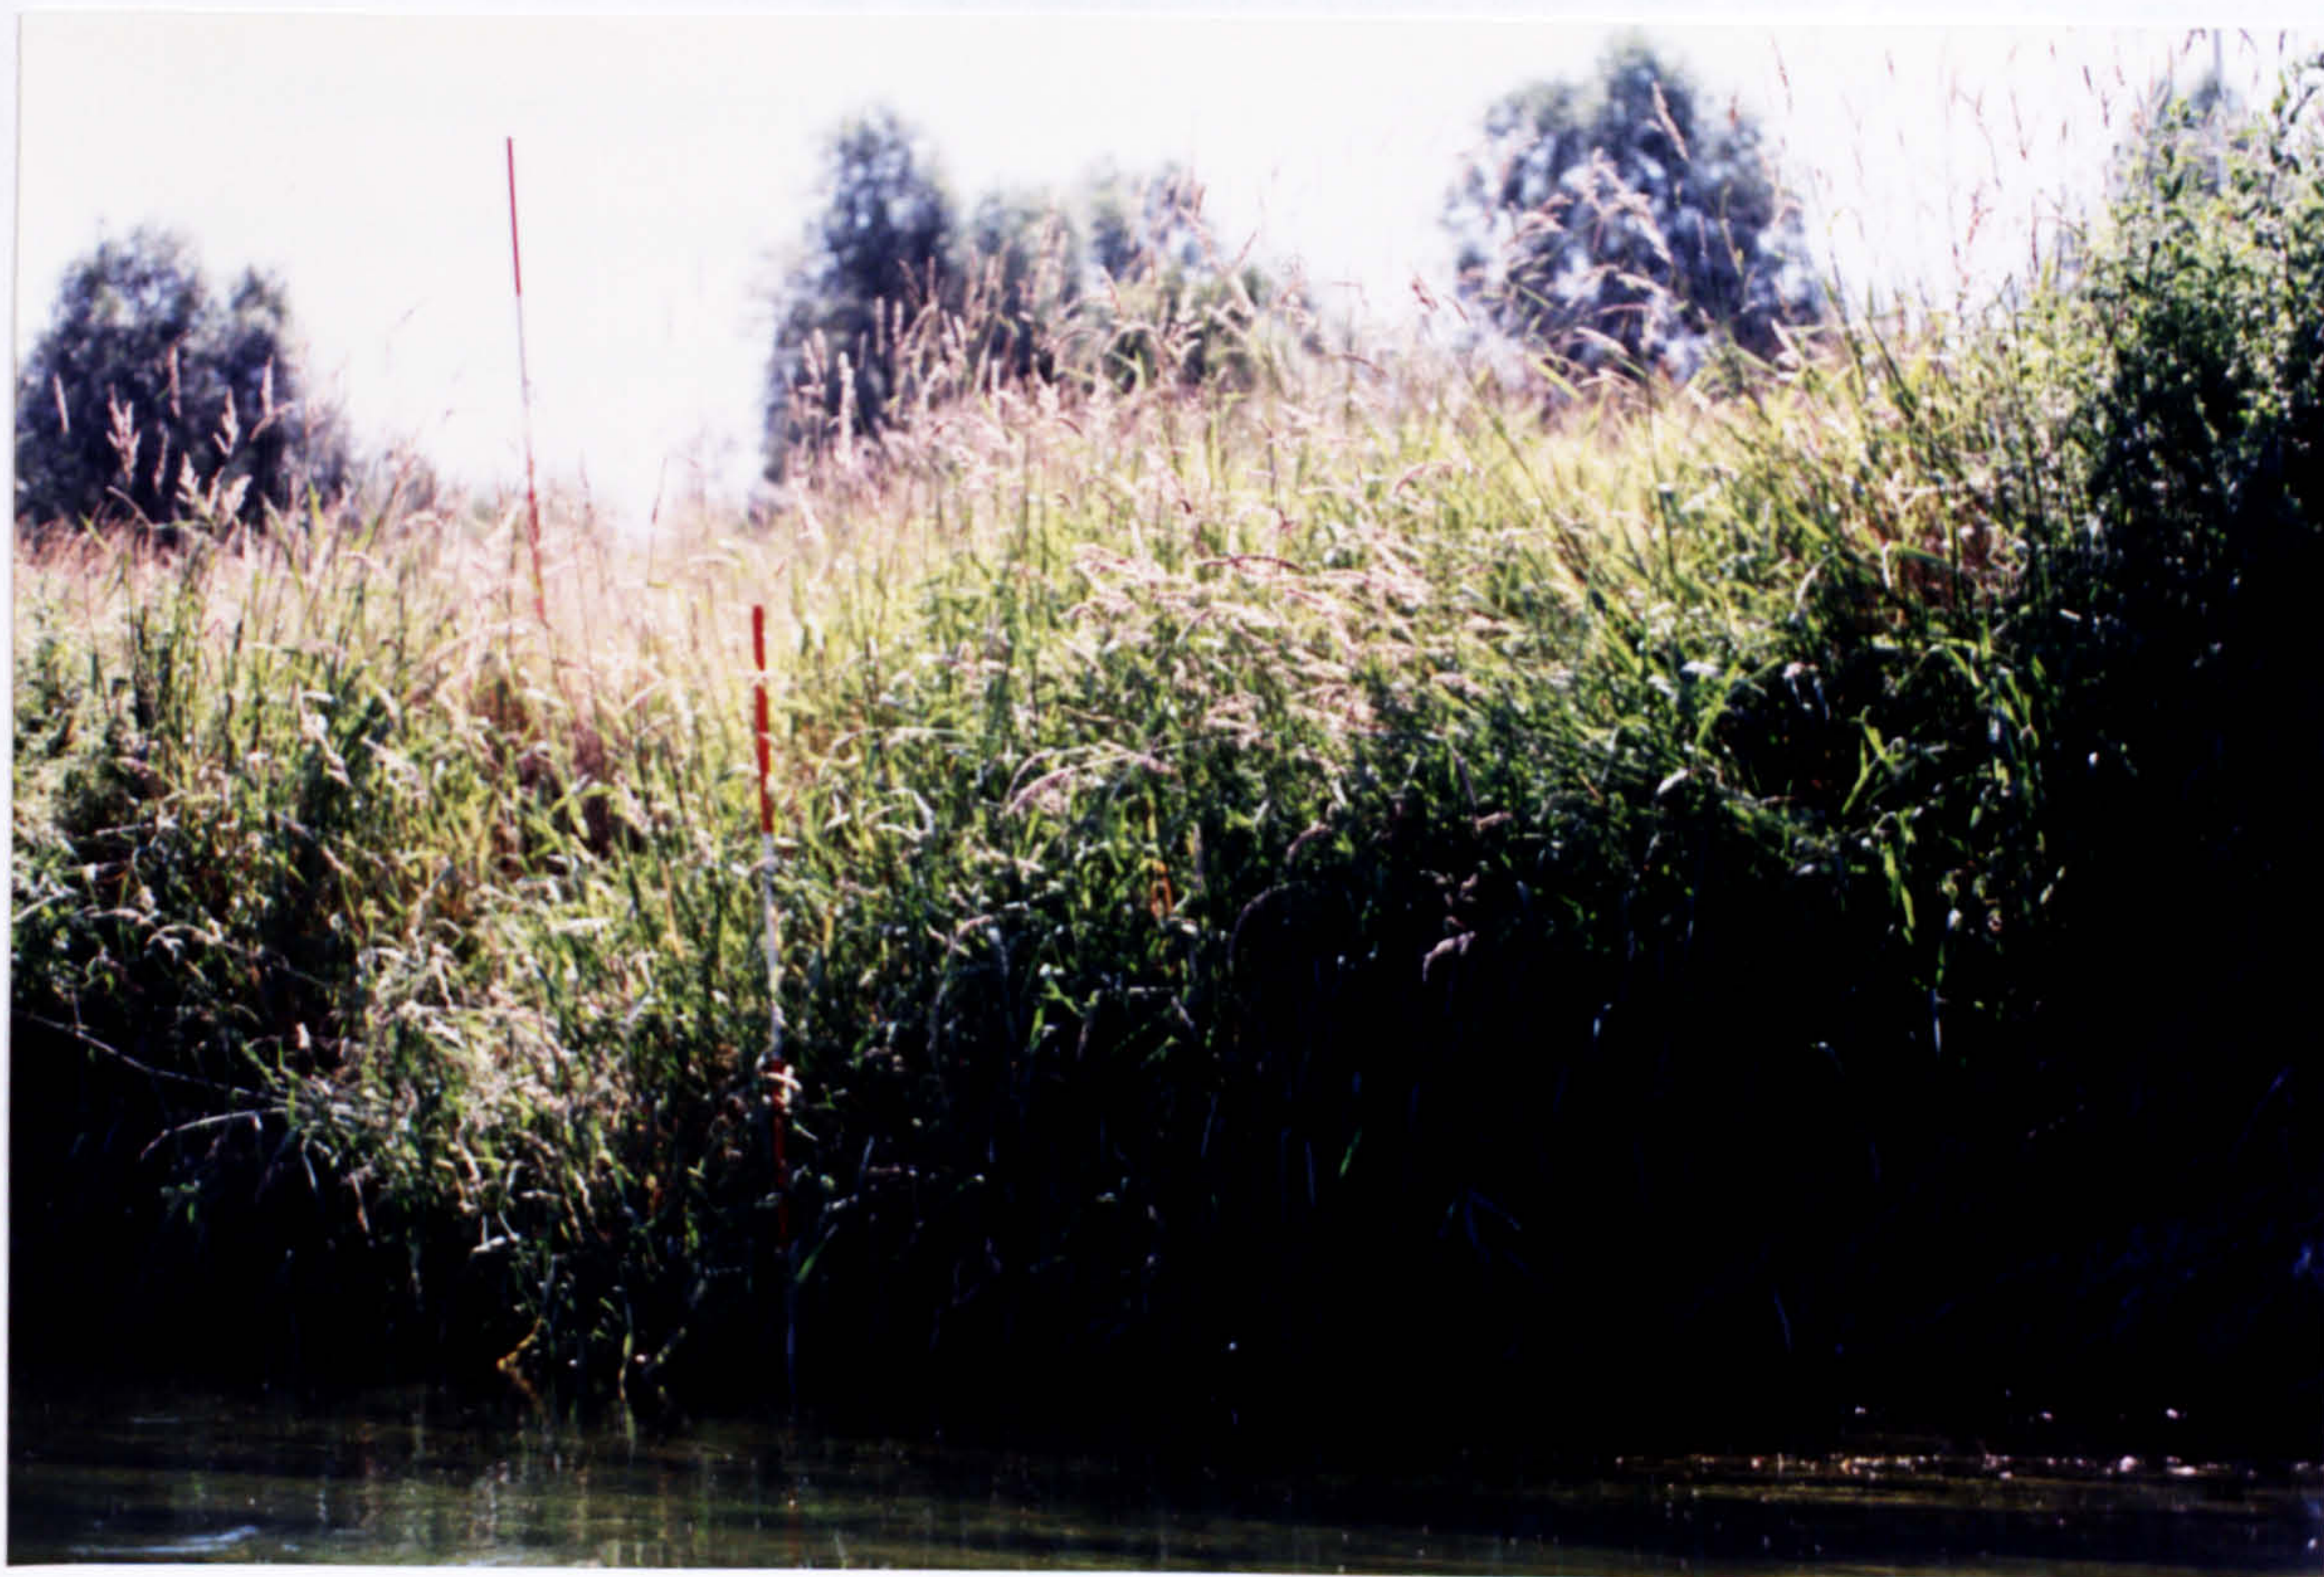
Plate 7. *Phalaris arundinacea* cultivated bank (Plot 2a) in August 1988

region) there was fast proliferation of *P. arundinacea* from Level 3 downwards to the waterline (see Plate 7). This was similar to the long-term established clumps of this species prevalent in other parts of the bank of this river and the larger River Ouse flowing through Buckinghamshire and Northamptonshire. The difference was that while the cultivated plots were a monoculture from the base to the top of the bank the naturally colonised clumps in other parts of the river were limited to Levels 1 and 2 mostly.

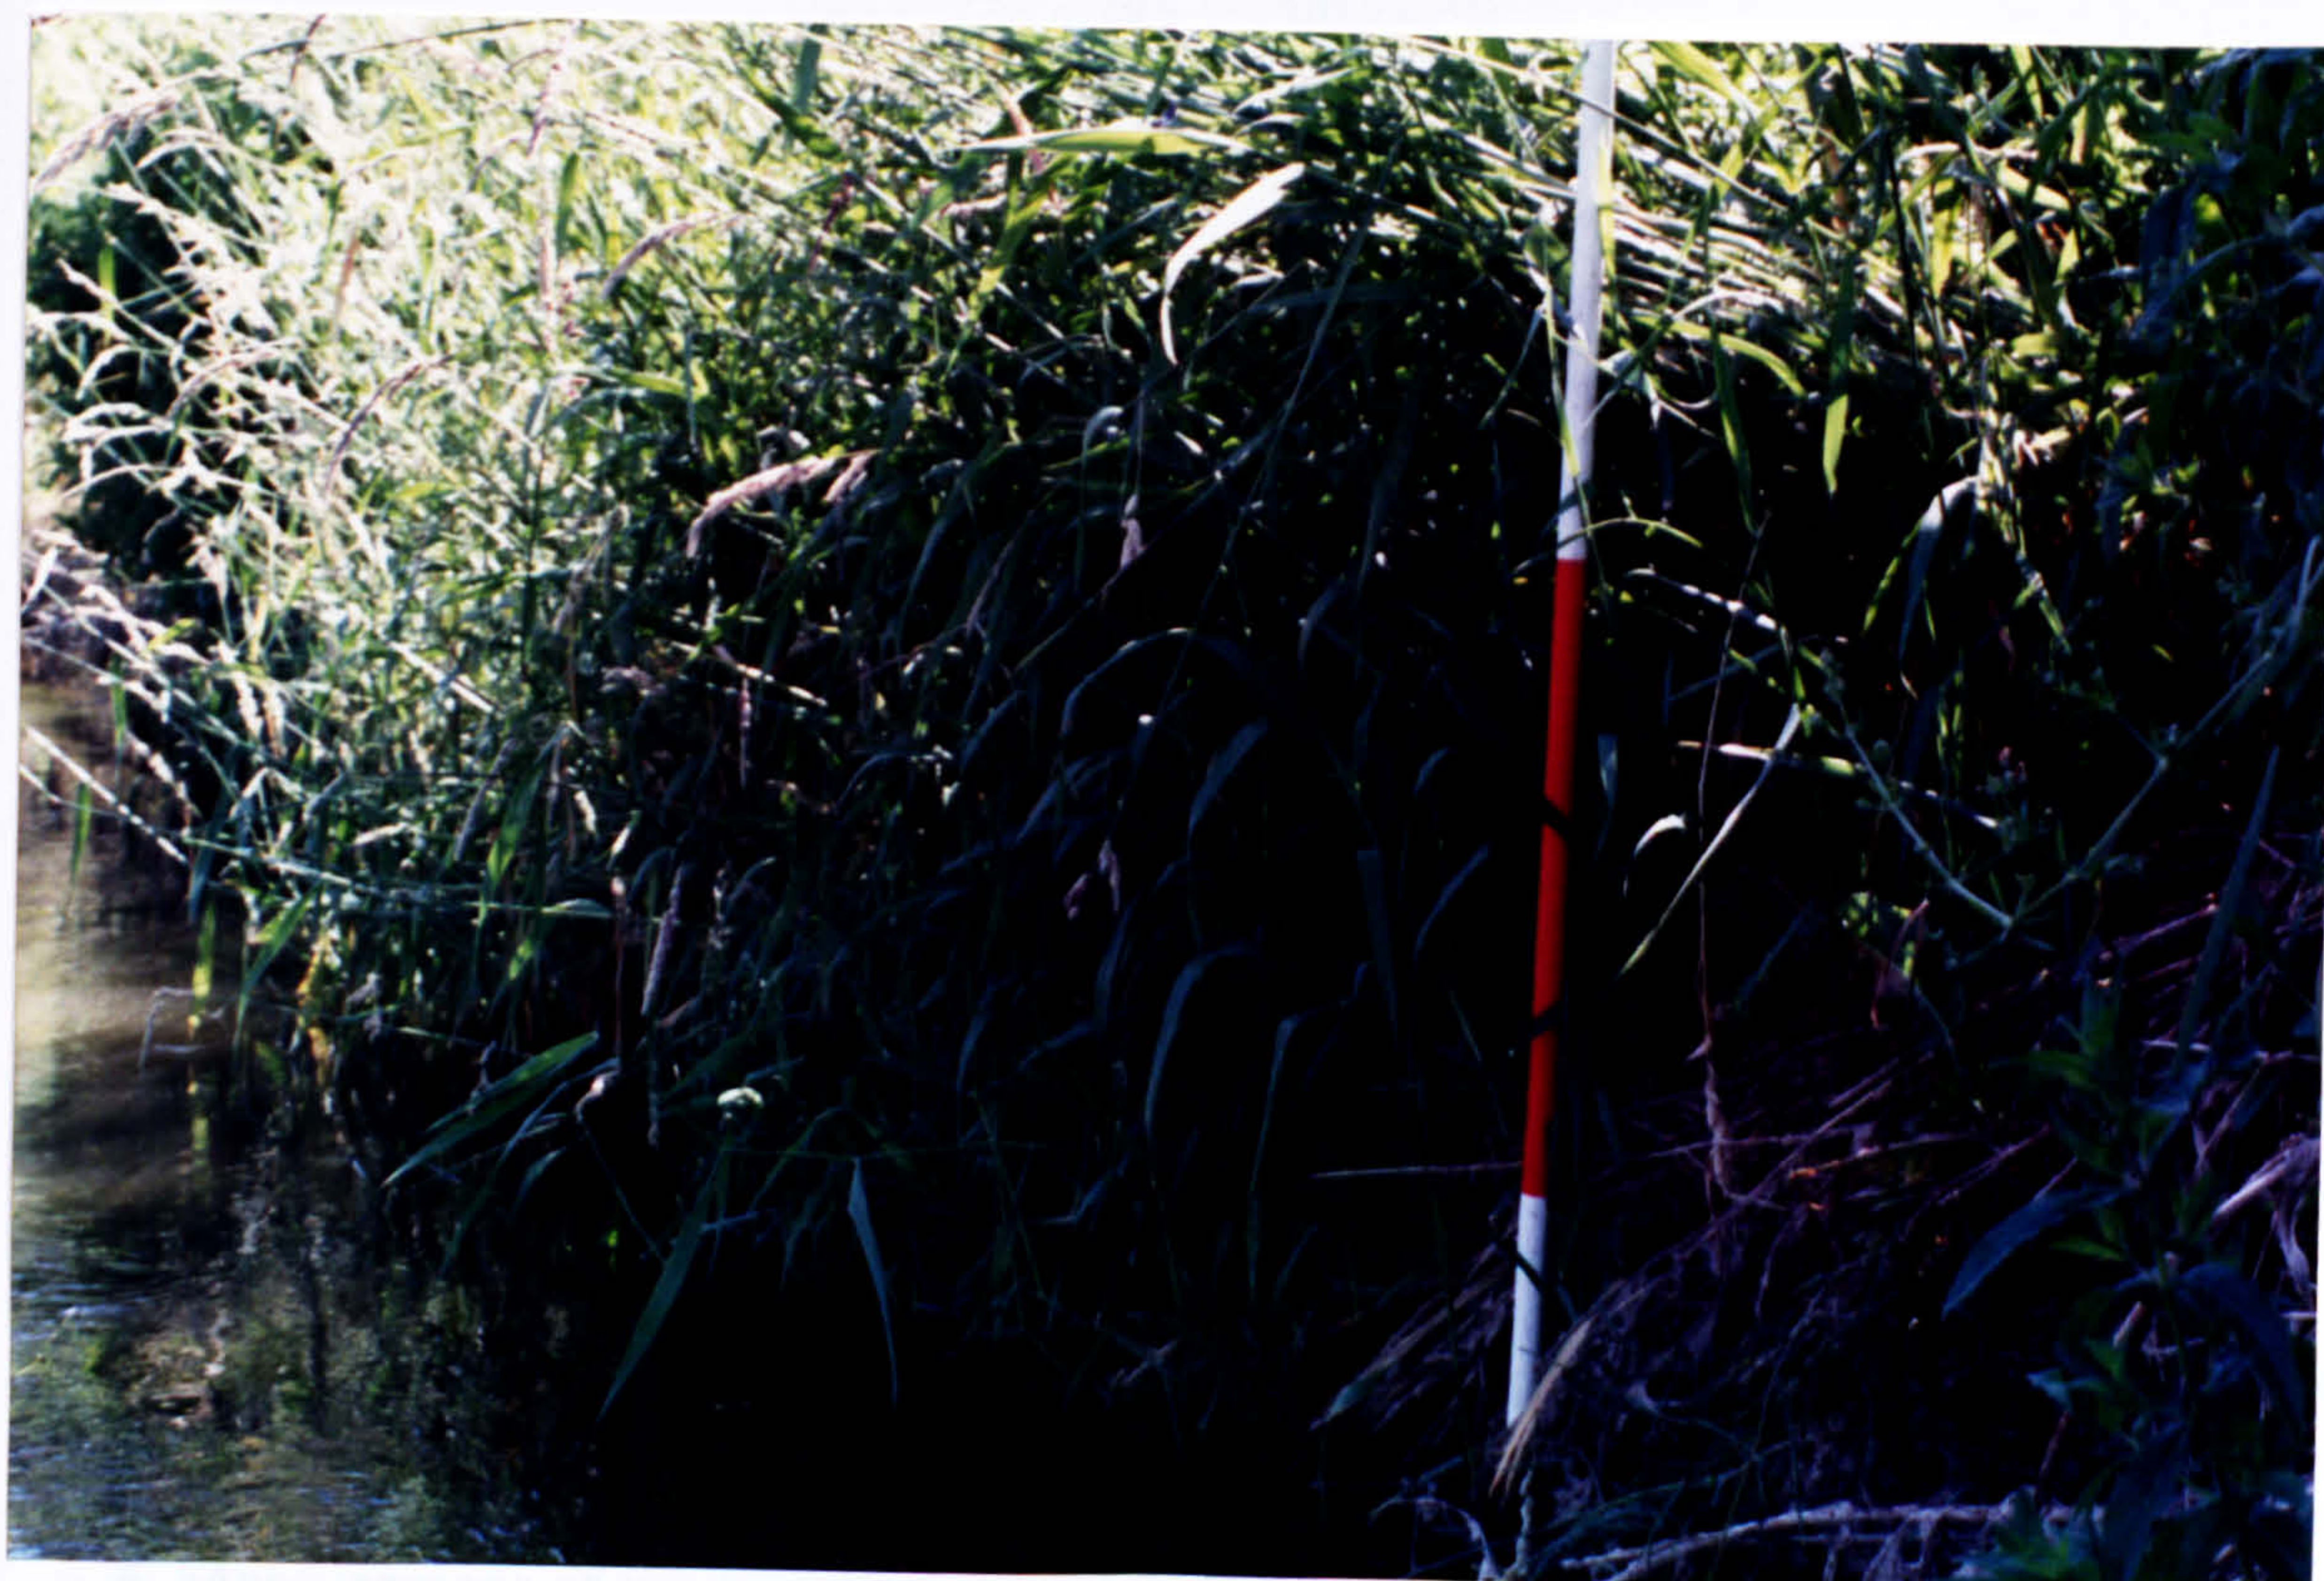
Plate 8. *Phalaris arundinacea* cultivated bank (Plot 2a/Lower bank) in August 1988
N.B. rapid colonisation of lower bank to waterline

It was only at the last stages of experimentation (Phase 5) that *P. arundinacea* colonised the toe-region (waterline) as shown in Plate 8. By this stage certain aspects of ecological significance were evident. They were (a) the toe-region was open to colonisation by any species; (b) the closest growing species was *P. arundinacea*; (c) the

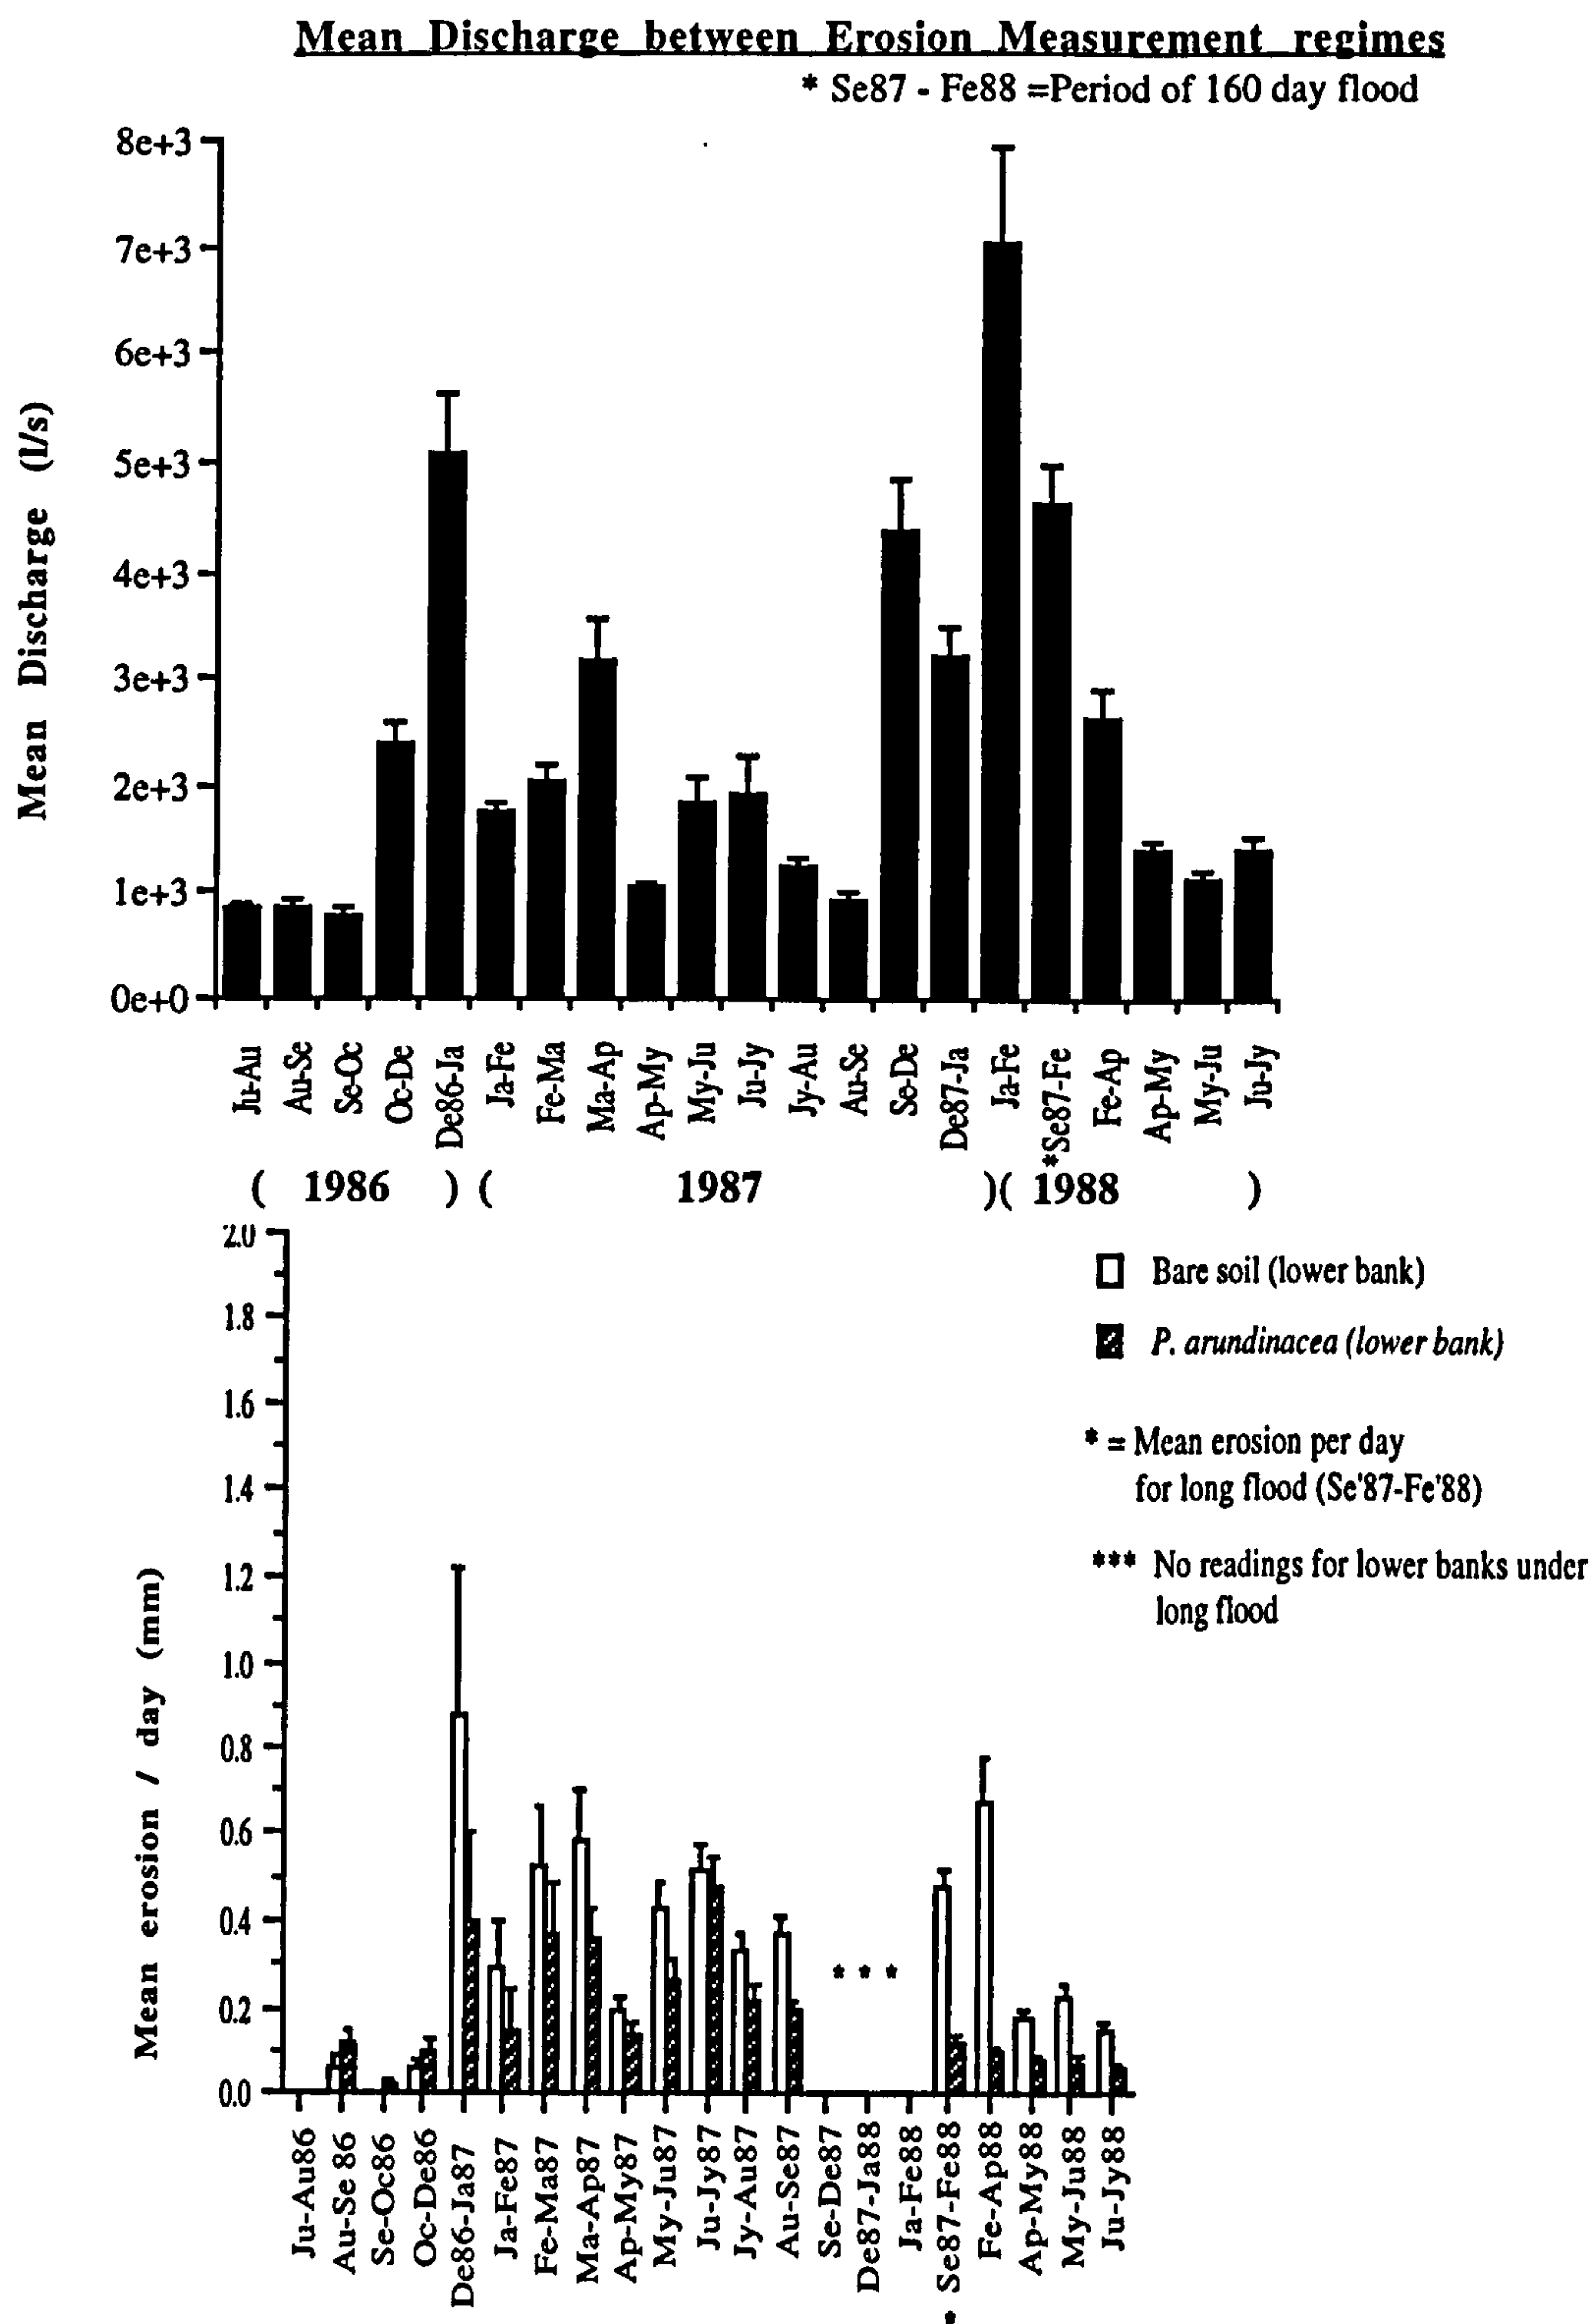
Fig. 4.5 : Comparison of Erosion: Bare soil Vs. *P. arundinacea* banks; (lower banks)
